CROC[®]
ForkCoating

A Croc that won't take a
"Bite" out of your budget!

The CROC-Team in action in civil engineering

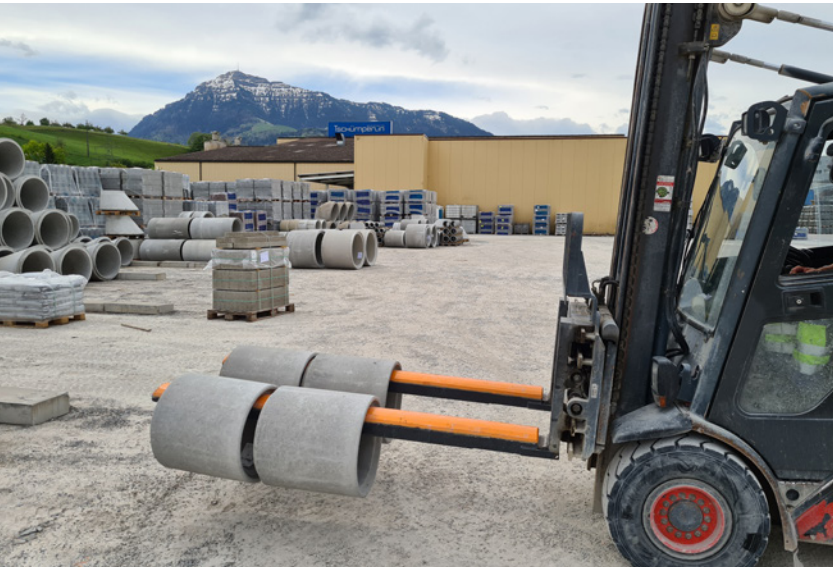
The problem: Concrete elements slip off the forks

The slippery surface of the forks, often also contaminated by concrete dust, causes problems especially when transporting concrete pipes, as these lose grip. In the worst case, a braking operation of the forklift causes the pipes to slip, resulting in damaged material.

The solution: The laterally rounded forks were coated with a 4 mm thick orange CROC spray coating. Thanks to the adaptability of the spray coating, a strong anti-slip effect can be achieved even on the rounded edges of the forks. The concrete elements are now transported gently and slipping is prevented, even in wet conditions. On top of this, the customer also benefits from a high level of noise reduction during transport.

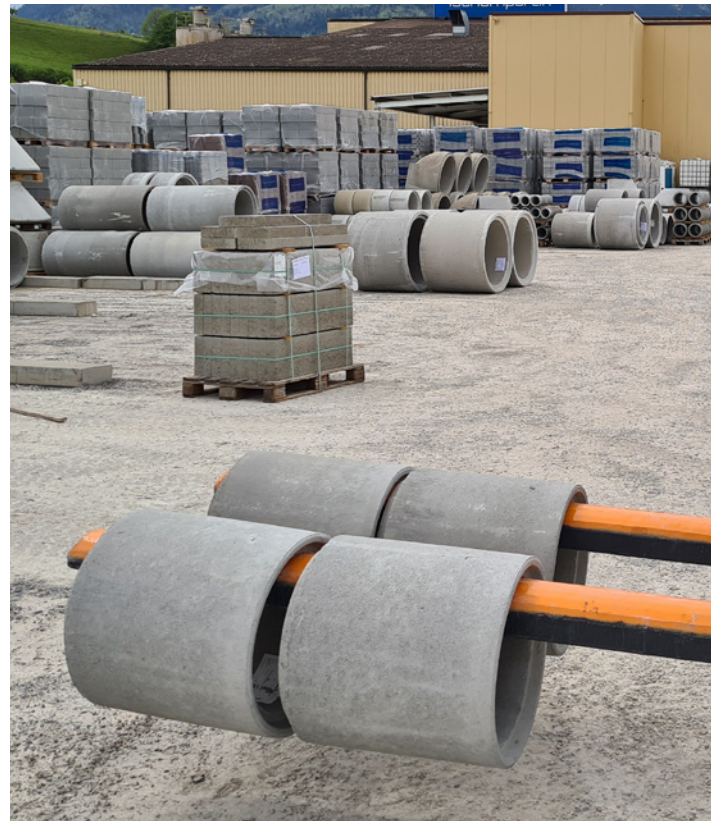
CROC Spray coating: Concrete elements do not slip off the forks
